Inspection 08/03/2017

Dakota House

De Havilland Drive, Weybridge, Surrey, KT13 OYP

Prepared for: Temperature Control

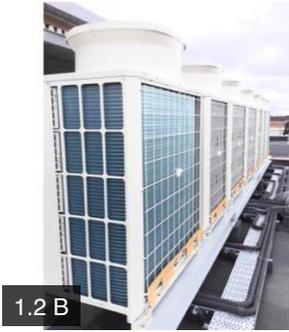
1.2 A

RESULT	COMMENTS
INSTALLATION AUDIT POINT		
1.1 First Fix?	Pass	First fix is 100% complete
1.2 Second Fix?	Pass	Second fix is approx 80% complete.
1.3 Pre-commissioning?	N/A	Site is not yet at this stage.
1.4 Being Commissioned?	N/A	Site is not yet at this stage, completion expected mid to end April.

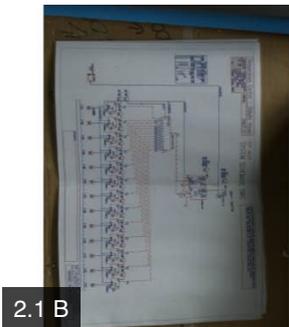
2.1 A

2.1 What system(s) has been installed?	Pass	VRF R2 with PEFY fan coils, Lossnay LGH 100, 3 AE200 Centralised Control - ground, first and shared for second and third. 1 x PWFY boiler unit for domestic hot water services. See typical schematics.
--	------	---

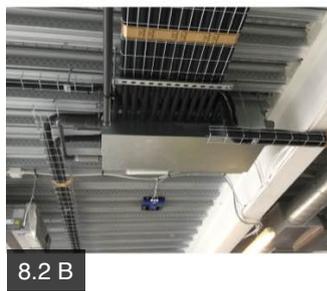
8.2 A

8.1 Has ACR grade copper pipework been used?	Pass	ACR grade copper pipework has been used throughout.
8.2 Have allowances been made to keep pipework clean and tidy?	Pass	Every effort has been made to keep pipework (and all materials) clean and tidy.

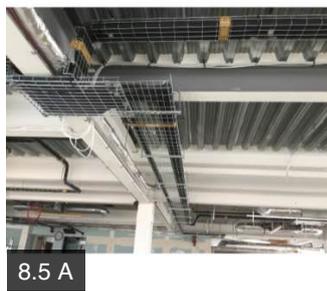
8.4 A

8.3 Has the use of OFN been witnessed during brazing?	Pass	No brazing was in progress during audit but OFN was witnessed as in use on site.
8.4 Have all unfinished copper pipework ends been capped/sealed off?	Pass	No unfinished copper pipework was seen during audit but copper pipe being made ready for use was seen to be capped.

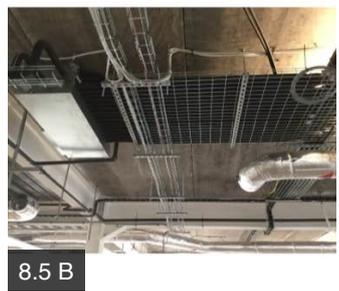
8.5 A

8.5 Is the support infrastructure adequate enough to support the refrigerant pipework and to acceptable distances?	Pass	The support infrastructure is adequate to support the refrigerant pipework and to acceptable distances.

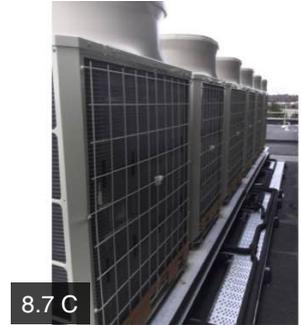
8.7 B

8.7 Has the pipework been installed neat and tidy?	Pass	The pipework throughout this site has been installed to a very high level of neatness.
8.8 Has the Armaflex insulation been installed neat and tidy with adequate vapour seal?	Pass	All Armaflex is installed in a tidy fashion with adequate vapour seals throughout.

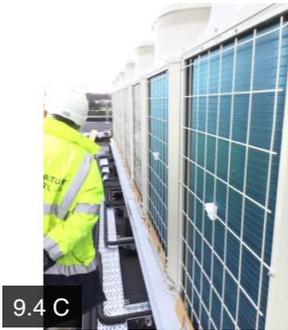
9.4 B

9.1 Has M-Net communication cable been installed using >1.25mm 2 core screened cable?	Pass	1.5mm 2 core screened communication cabling has been used.
9.2 Has M-Net communication cable been installed away from mains cables?	Pass	M-Net communication cable has been installed away from mains cables.
9.3 Have isolators been installed adjacent to I/U's?	Pass	Isolators seen installed adjacent to indoor units.
9.4 Have isolators been installed adjacent to O/U's?	Pass	Isolators seen adjacent to outdoor units (not obvious in photographs).
9.5 Have isolators been installed adjacent to BC's (if applicable)	Pass	Isolators seen adjacent to BCs.

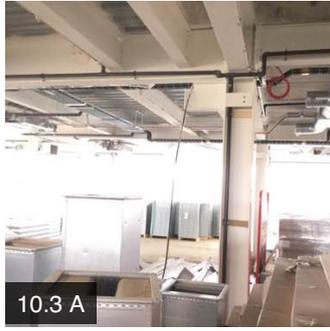
10.2 A

10.1 Has the condensate drain pipework and/or infrastructure been installed neat and tidy?	Pass	Condensate drain pipework is all well installed and tidy.
10.2 Has the condensate drain pipework and/or condensate pumps been installed to allow access for cleaning and maintenance on the I/U's	Pass	Installation enables access for cleaning and maintenance on I/U's
10.3 Has the condensate drain pipework been installed with a gradual fall throughout?	Pass	A gradual fall is evident.
10.4 Is condensation removed via condensate pumps, gravity or a combination of both?	Pass	Condensate drains are all gravity - no pumps.
10.5 Where has the condensate pipework been terminated?	Pass	Condensate pipework terminates in various toilets.

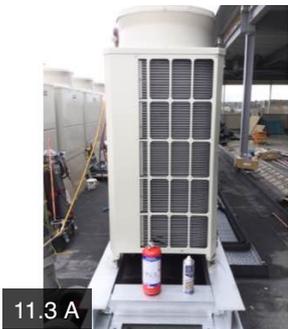
11.2 B

11.1 Have the BC boxes been installed so that they are accessible for Service and Maintenance? (R2 only)	Pass	BC boxes are positioned such that good access for service and maintenance is available via suspended ceiling panels.
11.2 Have the I/U's been installed so that they are accessible for Service and Maintenance, eg filters and control boxes?	Pass	I/U's have been installed such that good access is available via suspended ceiling panels (not yet installed).
11.3 Have the O/U's been installed so that they are accessible for Service and Maintenance?	Pass	Good access is available to outdoor units on the roof.
11.4 Have the O/U's been installed so as to negate any short cycling issues?	Pass	There would be no short cycling issues with the outdoor units as positioned.
