Inspection 08/03/2017

Dakota House

De Havilland Drive, Weybridge, Surrey, KT13 OYP

Prepared for: Temperature Control

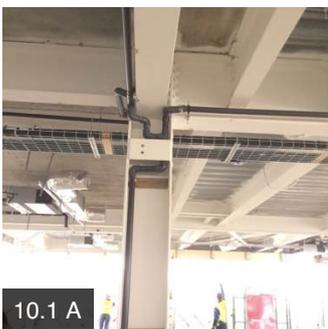
10.1 A

10.1 Has the condensate drain pipework and/or infrastructure been installed neat and tidy?	Pass	Condensate drain pipework is all well installed and tidy.
10.2 Has the condensate drain pipework and/or condensate pumps been installed to allow access for cleaning and maintenance on the I/U's	Pass	Installation enables access for cleaning and maintenance on I/U's
10.3 Has the condensate drain pipework been installed with a gradual fall throughout?	Pass	A gradual fall is evident.
10.4 Is condensation removed via condensate pumps, gravity or a combination of both?	Pass	Condensate drains are all gravity - no pumps.
10.5 Where has the condensate pipework been terminated?	Pass	Condensate pipework terminates in various toilets.
